RAILWAY INVESTIGATION REPORT

R03Q0022

MAIN-TRACK DERAILMENT

CANADIAN NATIONAL

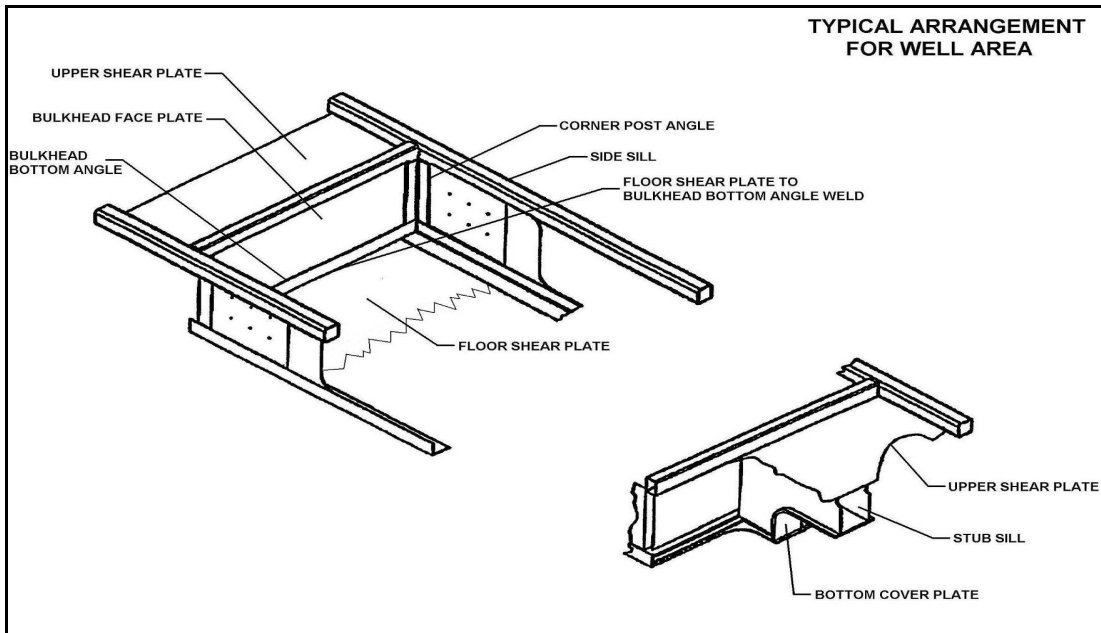
Figure 3. Sketch showing typical well arrangement and terminology for a container platform

In the stub sill area of the well, the floor and end wall (or bulkhead) of the car meet at a right angle (see Figure 3). The bulkhead bottom angle is attached between the floor shear plate and bulkhead face plate. Corner post angles are connected to the bulkhead face plates and the left and right sidewalls. All components are connected to each other with fillet welds.
